SUBJECT: Service Bulletin SEB89-1 Revision 3, Stabilator Balance Weight Arm Bracket Inspection Replacement.

SEB89-1 Revision 3

STABILATOR BALANCE WEIGHT ARM BRACKET INSPECTION REPLACEMENT

1968 thru 1978 Cardinal and Cardinal RG Series Airplanes

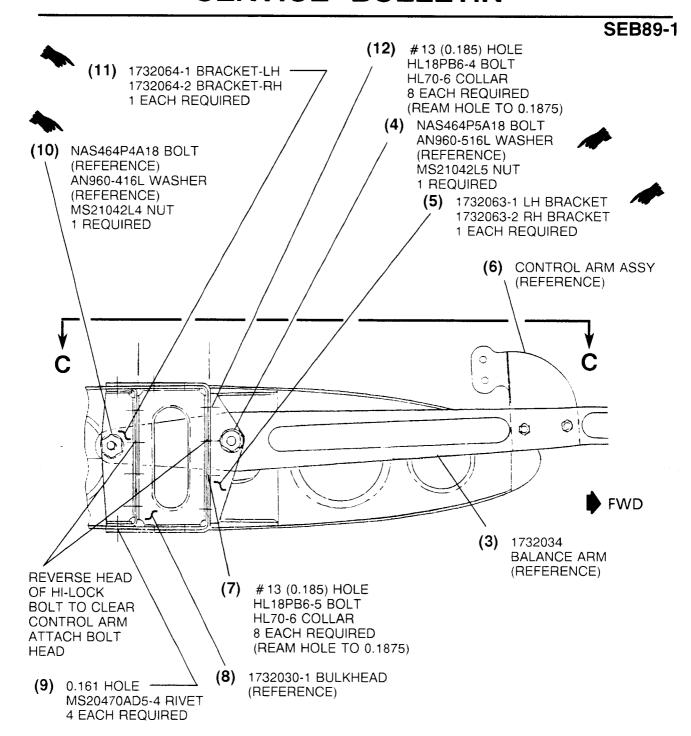
Figure 1. Stabilator Balance Weight Arm Brackets Inspection & Replacement (Sheet 2)

- 3. Visually inspect RH & LH brackets (5 & 11) for cracks, especially near the radius under the bolt hole. If no cracks are visible, use Eddy Current inspection to verify no small cracks have started.

- 2. Remove balance arm (3) from stabilator by removing bolts, washers and nuts (4 & 10), retain balance arm, bolts and washers, discard nuts (refer to Figure 1, Sheets 2 & 3).

- 5. If a crack or cracks are detected, proceed as follows.
 - 6. (Refer to Figure 1, Detail A, View B-B, C-C & D-D, Sheets 1 thru 4) With the balance arm removed, drill out existing rivets in location (7 & 12) on both RH & LH brackets (5). Remove and discard brackets.
